N.J. NO NAME
DAM NO. 51
NJ 00823

PHASE 1 INSPECTION REPORT
NATIONAL DAM SAFETY PROGRAM

REPT. NO: DAEN/NAP-53842/NJ00823-81/03

MARCH 1981

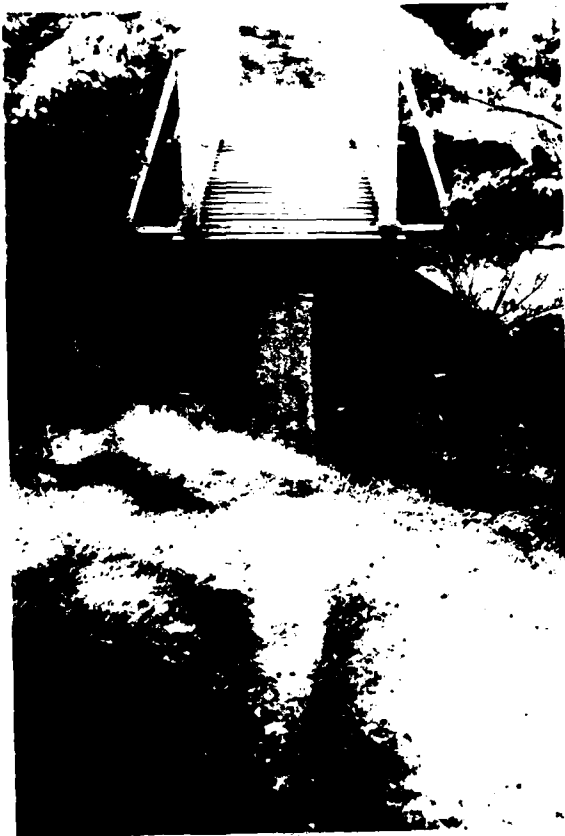
Exposed top of concrete core wall on north and south sides of spillway.

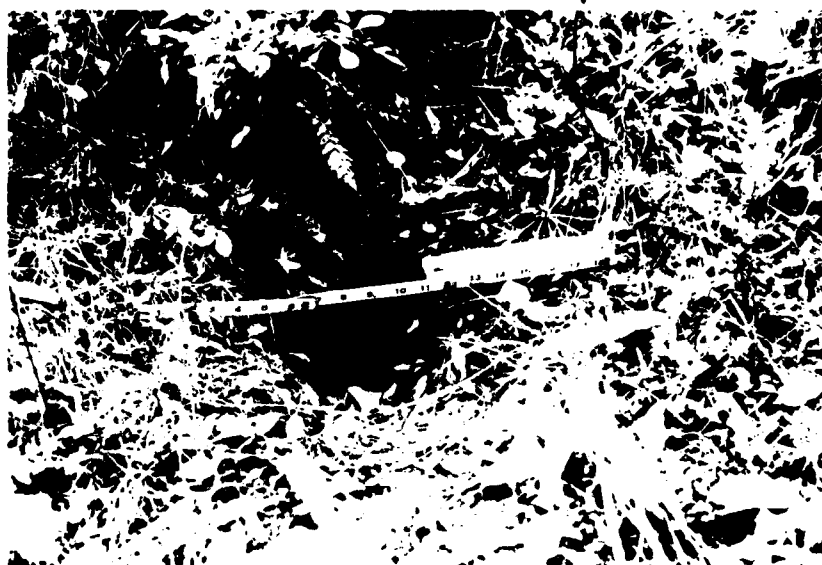
Animal burrow on downstream
embankment.
